Project **LIFE12NAT/LT/000965**
LIFEAUKSTUMALA Restoration of Aukstumala Raised Bog
in Nemunas Delta Regional Park

Hydrological Monitoring Methodology and Report, 2014

HYDROLOGICAL MONITORING AT THE TARGETED SITES

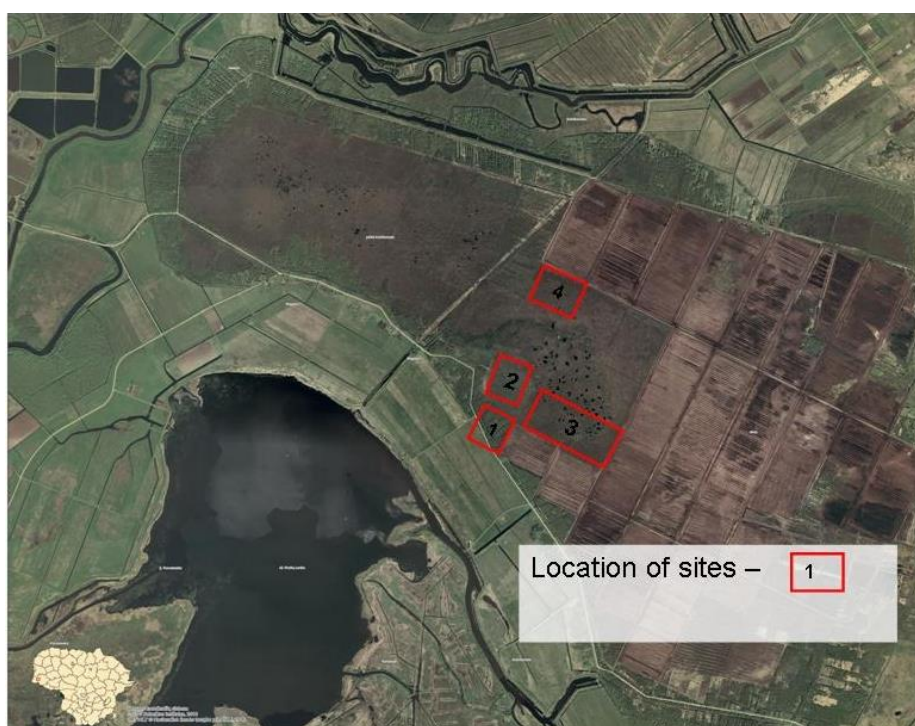
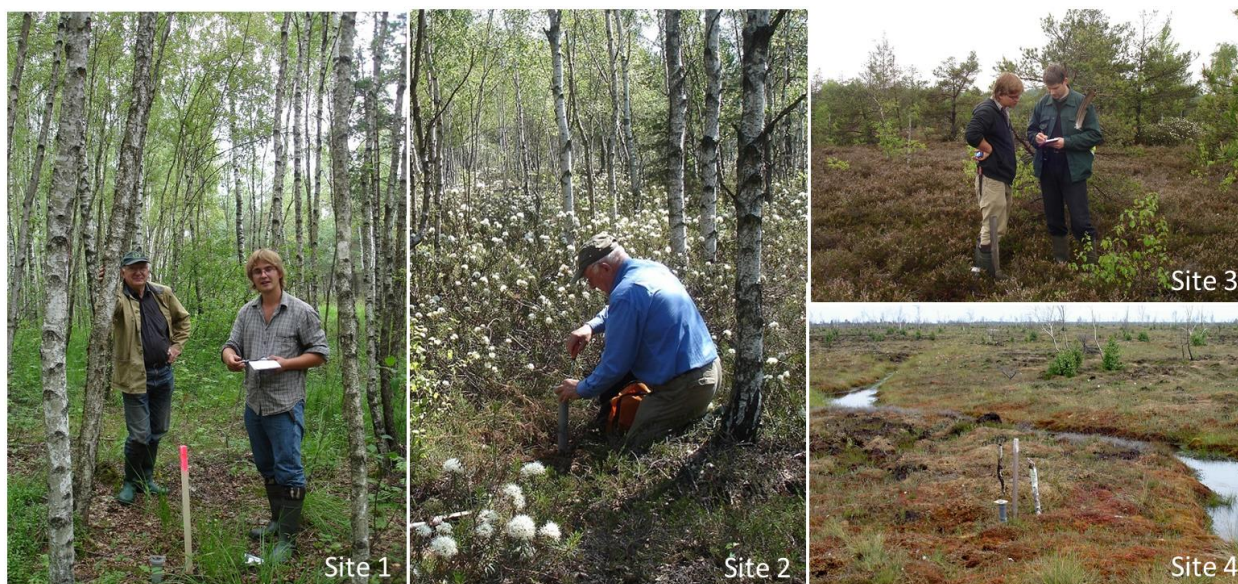
Fig. 1. Location of hydrological monitoring sites in Aukštumala Telmological Reserve

To assess the drainage effect on the hydrology of the Reserve, a hydrological monitoring system was installed (ten profiles with 6–10 water level measurement wells in each). For the installation of water level measurement wells, PVC tubes (diameter 50 mm, length 2 m, perforated along the full length) were inserted into 1.8 m peat deposit. To stop peat filling, the tube from the base was covered with nylon material. The top of the well was capped. The water level measurement was carried out with monthly interval during vegetation season in April–October, 2014. All hydrological monitoring profiles were grouped into 4 sites depending on hydrological conditions and the foreseen project actions (*Fig. 1*).

Hydrological monitoring profiles:

- **Site 1.** Two profiles (110 m length) with 6 water level measurement wells in each. Due to the old drainage system this site is characterised as degraded raised bog with intensive tree cover. In order to improve hydrological conditions, this site will be dammed. However, tree cuttings will not be carried out.

- **Site 2.** One profile (360 m length) with 10 water level measurement wells. The site is also qualified as degraded raised bog. Tree cuttings and dams will be carried out to improve hydrological conditions.

- **Site 3.** Six profiles (170 m length) with 9 water level measurement wells in each. Profiles are located in the contact zone of the Reserve and peat harvesting fields (southern, south-eastern part of the Reserve). None of the restoration measures will be taken.

- **Site 4.** Two profiles (170 m length) with 9 water level measurement wells in each. The site is located in the northern part of the Reserve, which was totally damaged by fire of 2011. The northern edge of the site is drained by 5–6 deep ditches. To improve hydrological conditions drainage ditches will be blocked.

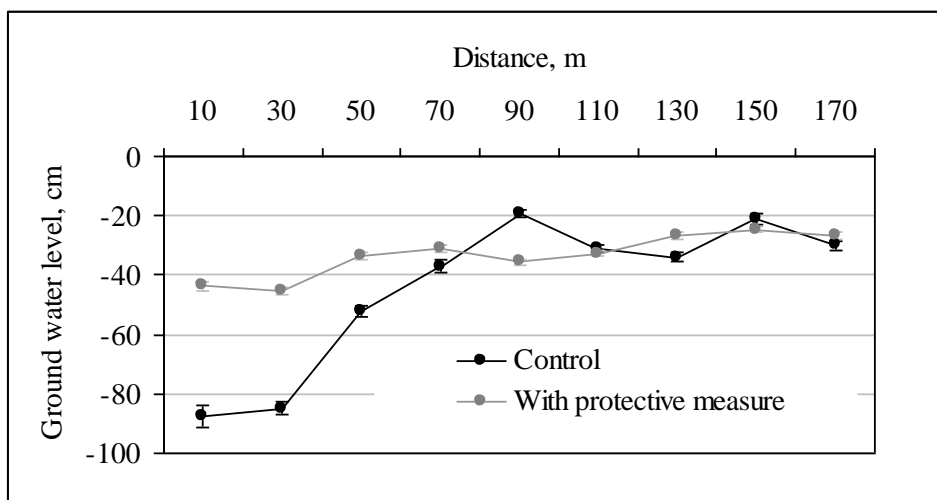
Fig. 4. Average ground water level in Site 3, Aukštumala Telmological Reserve, April–October, 2014

Site 3 is represented by relatively good hydrological conditions and open raised bog communities. However, the edge of the Reserve is under the impact of peat harvesting fields. As a result water level in the wells which are located in the contact zone (approx. 50 wide) is low and unfavourable for typical open raised bog habitats. In order to reduce negative impact posed by peat harvesting activity experimental polyethylene membrane (1 km length) in 2007 was installed. To assess the efficiency of polyethylene membrane ground water level was measured in 3 profiles with protective measure in 3

control profiles (without protective measure). Curves in Fig. 4 illustrate mean ground water level in both treated and untreated sites in 2007–2014 period. Polyethylene membrane turned out to be an efficient measure to retain water in the bog and mitigate negative hydrological impact of peat harvesting from adjacent fields. Moreover, in further distant wells (70–170 m) water level remained relatively high and favourable for peat accumulation process in both (control and treated) profiles.

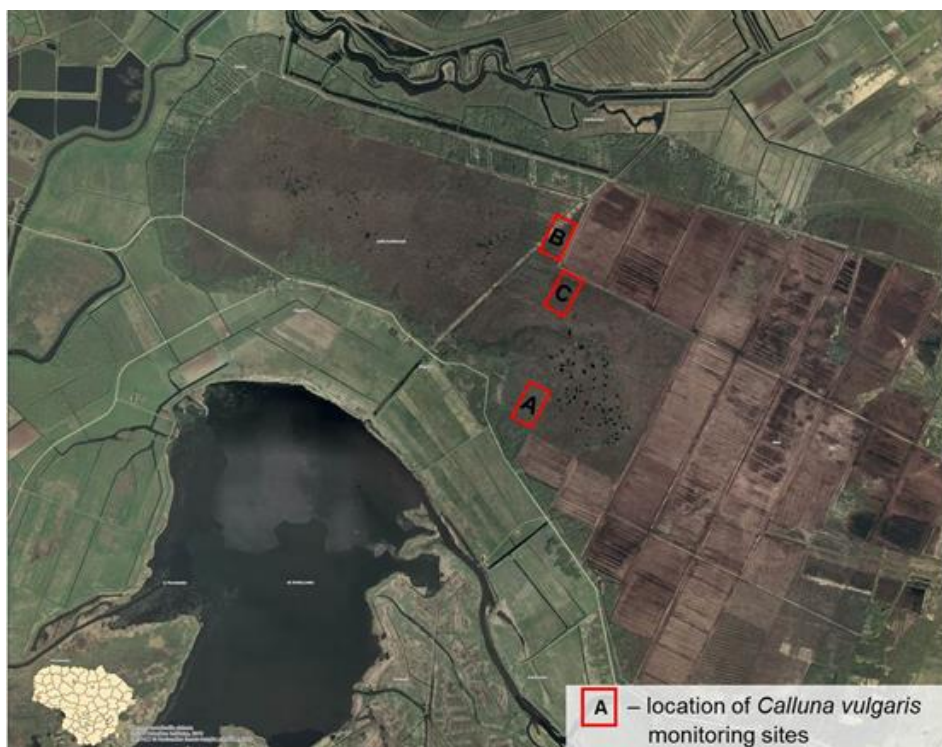
Fig. 6. Location of *Calluna vulgaris* monitoring transects (A–C) in Aukštumala Telmological Reserve

The percentage cover of *Calluna vulgaris* was estimated in August of 2014. Three linear transects (A, B, C) were established in the degraded parts of Aukštumala Telmological Reserve (Fig. 6).

- **Transect A** (380 m length) was established in degraded raised bog area with dense net of drainage ditches and low water level. 20 permanent study plots (1.0×1.0 m in size) were distributed every 20 m in the transect. The site is characterised by dominant tree cover (*Betula pendula*, *B. pubescens*, *Pinus sylvestris*), well developed *Ledum palustre* and sparse coverage of grasses and *Sphagnum* mosses (up to 5 %).
- **Transect B** (180 m length) was established in damaged by fire area with dense net of drainage ditches and low water level. 10 permanent study plots (1.0×1.0 m in size) were distributed every 20 m. Before the fire 2011, the site was overgrown by 30-40 years old *Betula pendula*, *B. pubescens*, *Pinus sylvestris* trees stand with well-developed *Calluna*

vulgaris dwarf-shrubs, while *Sphagnum* cover was absent. During the above mentioned fire almost all woody vegetation was burned. Heather quickly recovered after the fire and currently *Calluna vulgaris* dominate in the vegetation cover.

- **Transect C** (180 m length) was established in damaged by fire area, perpendicularly to the contact line of the Reserve and peat harvesting fields. 10 permanent study plots (1.0×1.0 m in size) were distributed every 20 m. The northern edge of the transect (degraded raised bog area) was influenced by 5-6 actively working ditches, which were dammed right after the fire. In the southern edge of the transect is located in the active raised bog area.

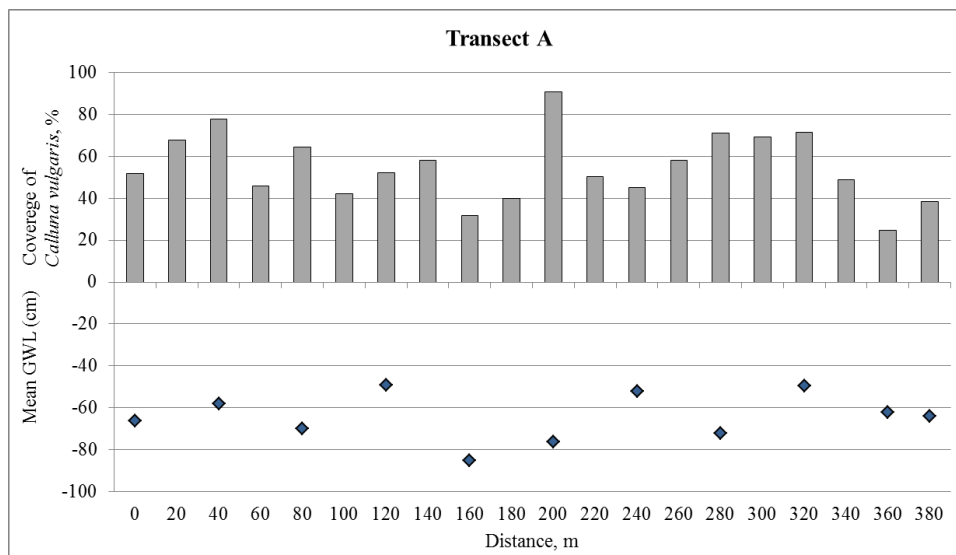
Transect A. The site was drained by dense net of ditches, vegetation cover was removed and prepared for industrial peat harvesting in the late 80's of 20th century. Currently the site is characterised by degraded raised bog communities with dominant woody vegetation. *Calluna vulgaris* coverage ranged from 25% (in the contact zone with active raised bog) to 91% (mean 55%) in permanent study plots (Fig. 7–8). Because of low water level (mean water level during vegetation season -64 cm) *Sphagnum* cover is sparse (up to 5%) and replaced by brown mosses (*Pleurozium shreberi*, *Dicranum polysetum*, *Polytrichum strictum*). However, it should be noted that in the northern edge of the transect (which adjacent to active raised bog area) *Sphagnum* mosses covers up to 80–90% of study plots.

Fig. 8. Coverage of *Calluna vulgaris* (%) and mean ground water level (cm) in the Transect A, Aukštumala Telmological Reserve, 2014

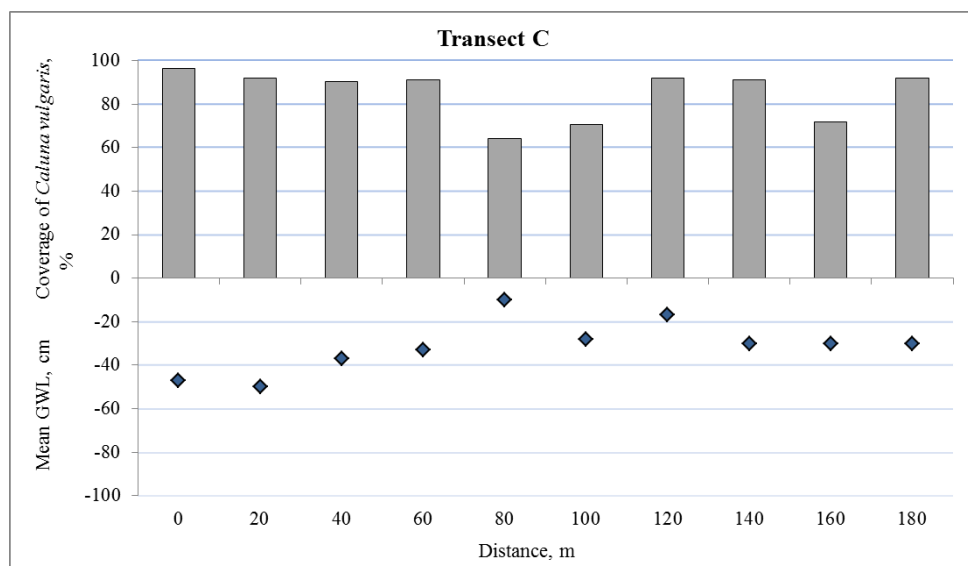
Transect C. The site is negatively influenced by peat harvesting. Moreover, the northern part of the transect (up to 60 m length) is affected by 5 drainage ditches. The area is also damaged by fire in 2011. Vegetation cover in drained area (degraded raised bog) was burned out completely, whereas in the rest part of transect C (active raised bog) was strongly damaged. Currently *Calluna vulgaris* dominate in one third of the transect (up to 60 m length) – 64–97%, whereas in the rest part of the

transect *Calluna vulgaris* coverage is more related with microtopography (from 0% in depressions to 86% in hummocks; Fig. 10). Although water level compared with above mentioned sites is relatively high (average -31 cm), the coverage of *Calluna vulgaris* is still dense and not typical to open raised bog communities. This site has a biggest potential for the changes towards active raised bog vegetation, because of presence of typical raised bog species (*Rubus chamaemorus*, *Rhynchospora alba*, *Oxycoccus palustris*, *Andromeda polifolia*, *Eriophorum vaginatum*, *Drosera anglica*, *D. rotundifolia*, *Sphagnum magellanicum*, *S. fuscum.*, *S. rubellum* etc.).

Fig. 10. Coverage of *Calluna vulgaris* (%) and mean ground water level (cm) in the Transect C, Aukštumala Telmological Reserve, 2014
