Project **LIFE12NAT/LT/000965**
LIFEAUKSTUMALA Restoration of Aukstumala Raised Bog
in Nemunas Delta Regional Park

Action D2:

HYDROLOGICAL MONITORING AT THE TARGETED SITES

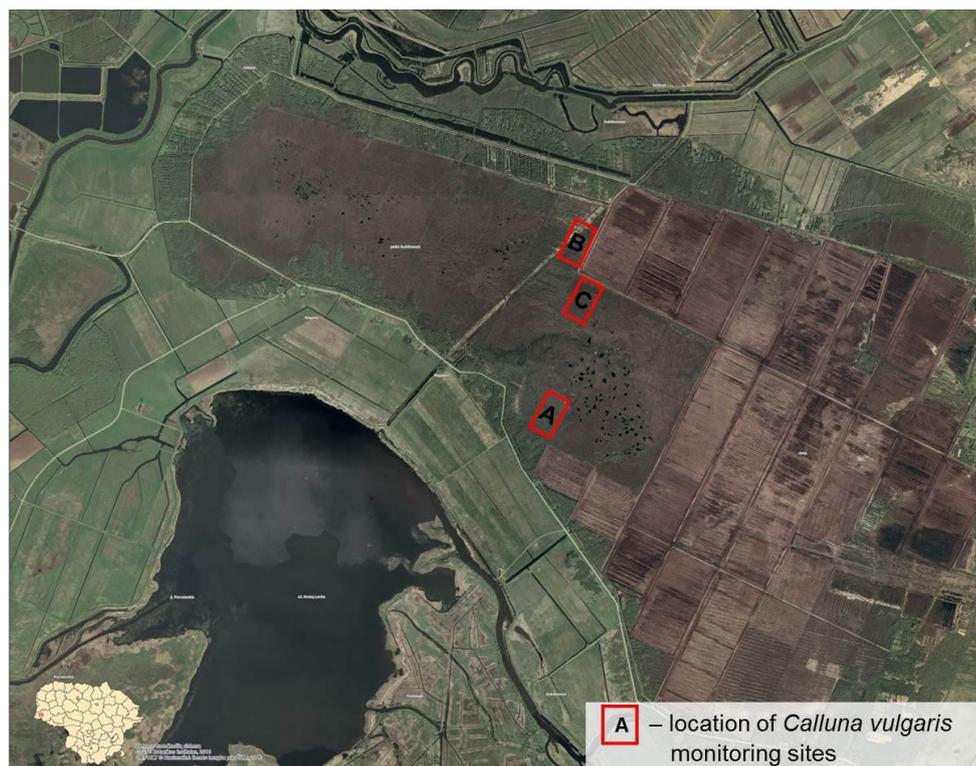
Fig.10. Location of vegetation monitoring sites in Aukštumala Telmological Reserve

- **Transect A:** 380 m length transect was established in degraded raised bog area with dense net of drainage ditches and low water level. The site is characterised by dominant tree cover (*Betula pendula*, *B. pubescens*, *Pinus sylvestris*). 20 study plots, (Fig. 10.) were distributed every 20 m.

- **Transect B:** 180 m length transect was established in fire damaged area with dense net of drainage ditches and low water level. Before the fire (2011) the site was characterised by dominant tree cover (*Betula pendula*, *B. pubescens*, *Pinus sylvestris*), *Sphagnum* cover was absent. Currently dwarf-shrubs *Calluna vulgaris* dominate in the vegetation cover. 10 study plots were distributed every 20 m.

- **Transect C:** 180 m length transect was established in damaged by fire area, perpendicularly to the contact line of the Reserve and peat harvesting fields. The northern edge of the transect is drained by ditches (degraded raised bog), whereas southern is characterised by open raised bog communities. 10 study plots were distributed every 20 m.
